# **PLASTIC PIPING DATA COLLECTION INITIATIVE STATUS REPORT**

June 2024

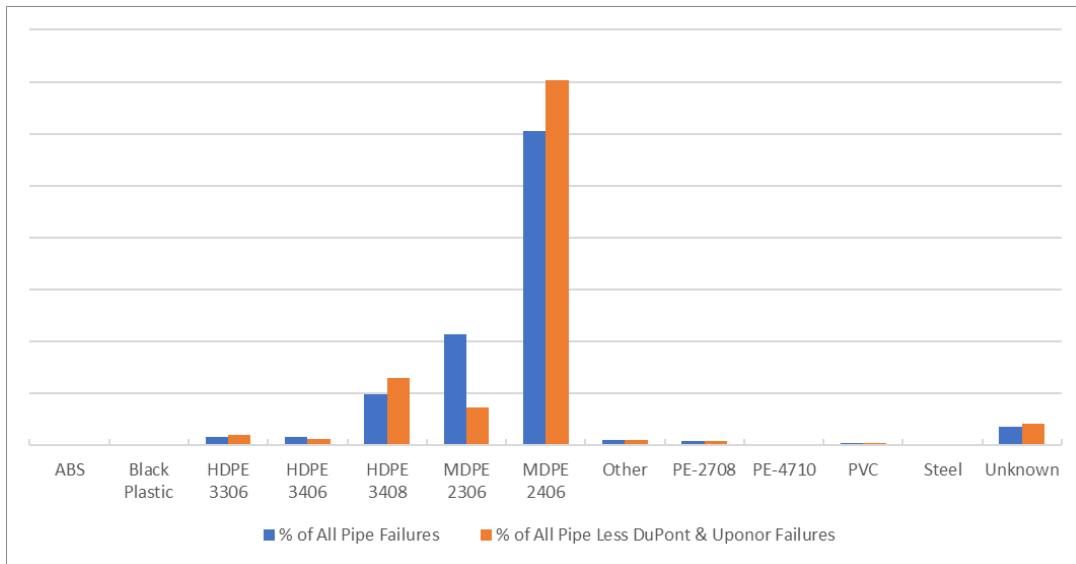
### B3. All Pipe Failures by Material

Material	% of All Pipe Failures	% of All Pipe Less DuPont & Uponor Failures
ABS	0.1%	0.1%
Black Plastic	0.1%	0.1%
HDPE 3306	1.4%	1.9%
HDPE 3406	1.6%	1.1%
HDPE 3408	9.7%	12.9%
MDPE 2306	21.4%	7.3%
MDPE 2406	60.5%	70.3%
Other	0.8%	1.0%
PE-2708	0.6%	0.8%
PE-4710	0.0%	0.1%
PVC	0.3%	0.3%
Steel	0.1%	0.1%
Unknown	3.5%	4.0%
<b>Total</b>	<b>100.0%</b>	<b>100.0%</b>

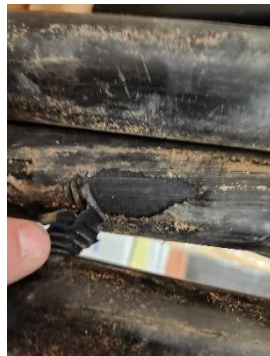
Figure 4

Figures 4 & 5 show external degradation is a peeling effect of the pipe.

**Response from PPDC:** A review of current PPDC data does not correspond with internal degradation processes. The PPDC will continue monitoring data for potential Drisco 8000 internal pipe wall issues with cracking and brittleness and external degradation of peeling of the pipe.
