PLASTIC PIPING DATA COLLECTION INITIATIVE STATUS REPORT

~~November 2023~~ June 2024

**Administered by
American Gas Association
400 North Capitol Street, N.W., 4th Floor
Washington, DC 20001
U.S.A.**

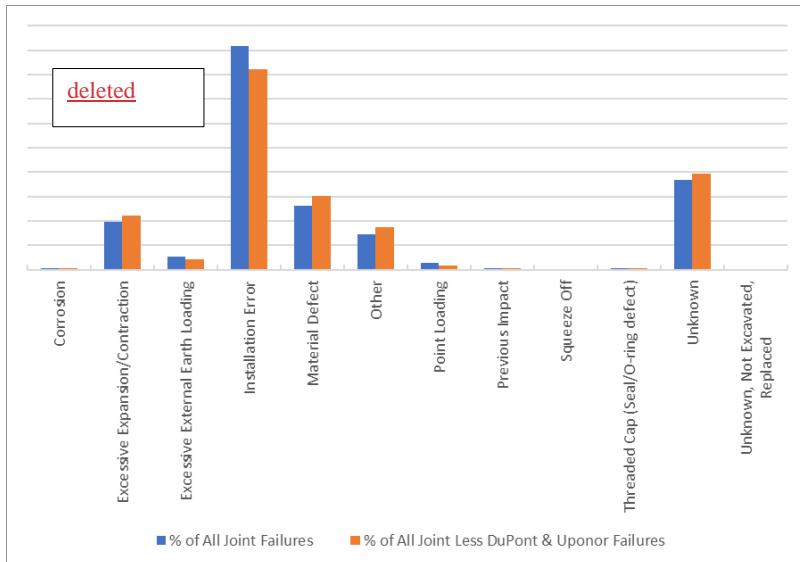
B6. All Joint Failures by Cause

Note: The Committee noted an increase in failures in “Excessive Expansion/Contraction” beginning in 2021 (October 2022 Meeting)

Cause	% of All Joint Failures	% of All Joint Less DuPont & Uponor Failures
Corrosion	0.3%	0.3%
Excessive Expansion/Contraction	12.8 9.9%	14.7 11.2%
Excessive External Earth Loading	2.5 2.8%	1.9 2.1%
Installation Error	45.2 45.9%	40.5 41.0%
Material Defect	12.1 13.2%	13.7 15.1%
Other	7.1 7.3%	8.2 8.7%
Point Loading	1.5%	0.9%
Previous Impact	0.3%	0.2 0.3%
Squeeze Off	0.1%	0.1%
Threaded Cap (Seal/O-ring defect)	0.4 0.3%	0.5 0.3%
Unknown	17.7 18.4%	18.8 19.7%
<u>Unknown- Abandoned</u>	0.0%	0.1%
Unknown - Not Excavated, Replaced	0.2%	0.2%
Total	100.0%	100.0%

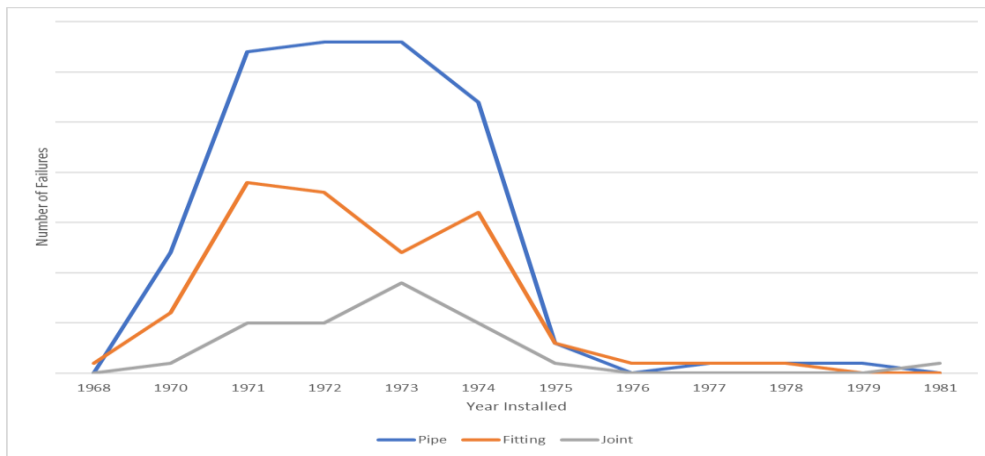
Figure 1. Failures by Years Installed as Reported to PPDC for Century Pipe, Fittings and Joints

Century represent less than 1% of all the reports in the database. The majority of the reported Century failures occur on pipe (56%). Other categories include fittings (32%), joints (11%) and unknown (1%). The distribution of failures for pipe, fittings and joints by year installed is shown in Figure 1. The figure shows the majority of failures occurred on pipe installed from 1970 to 1974.

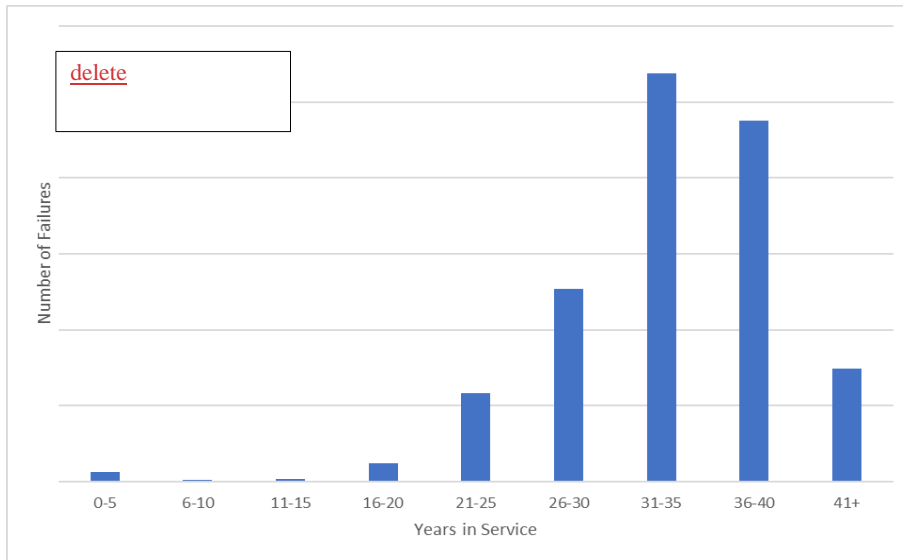
Figure 2. AMP Failures by Years in Service, 5 year intervals

The distribution of failures for AMP by years in service is shown in Figure 2.
